Operation and Maintenance Report
January 2017 to December 2017

McCormick and Baxter Superfund Site

Portland, Oregon
ECSI Site No. 74

March 29, 2018
15670-10/Task 4

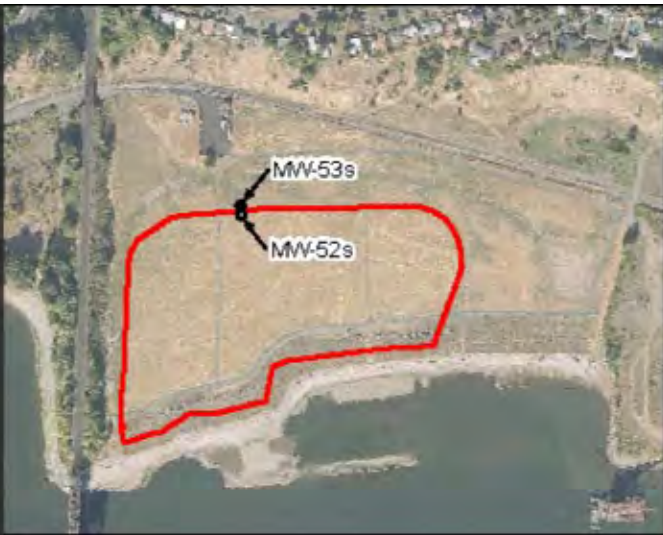
Figure 4-5:
2017 Groundwater Elevations
Monitoring Wells MW-52s and MW-53s

The break in MW-52s data (Figure 4-5) occurred as a result of water damage in the probe, which was identified in the June semiannual event. The transducer was sent in for repairs and re-installed in August. Currently, all transducers at the site are functional and installed in the wells shown on Figure 4-1.

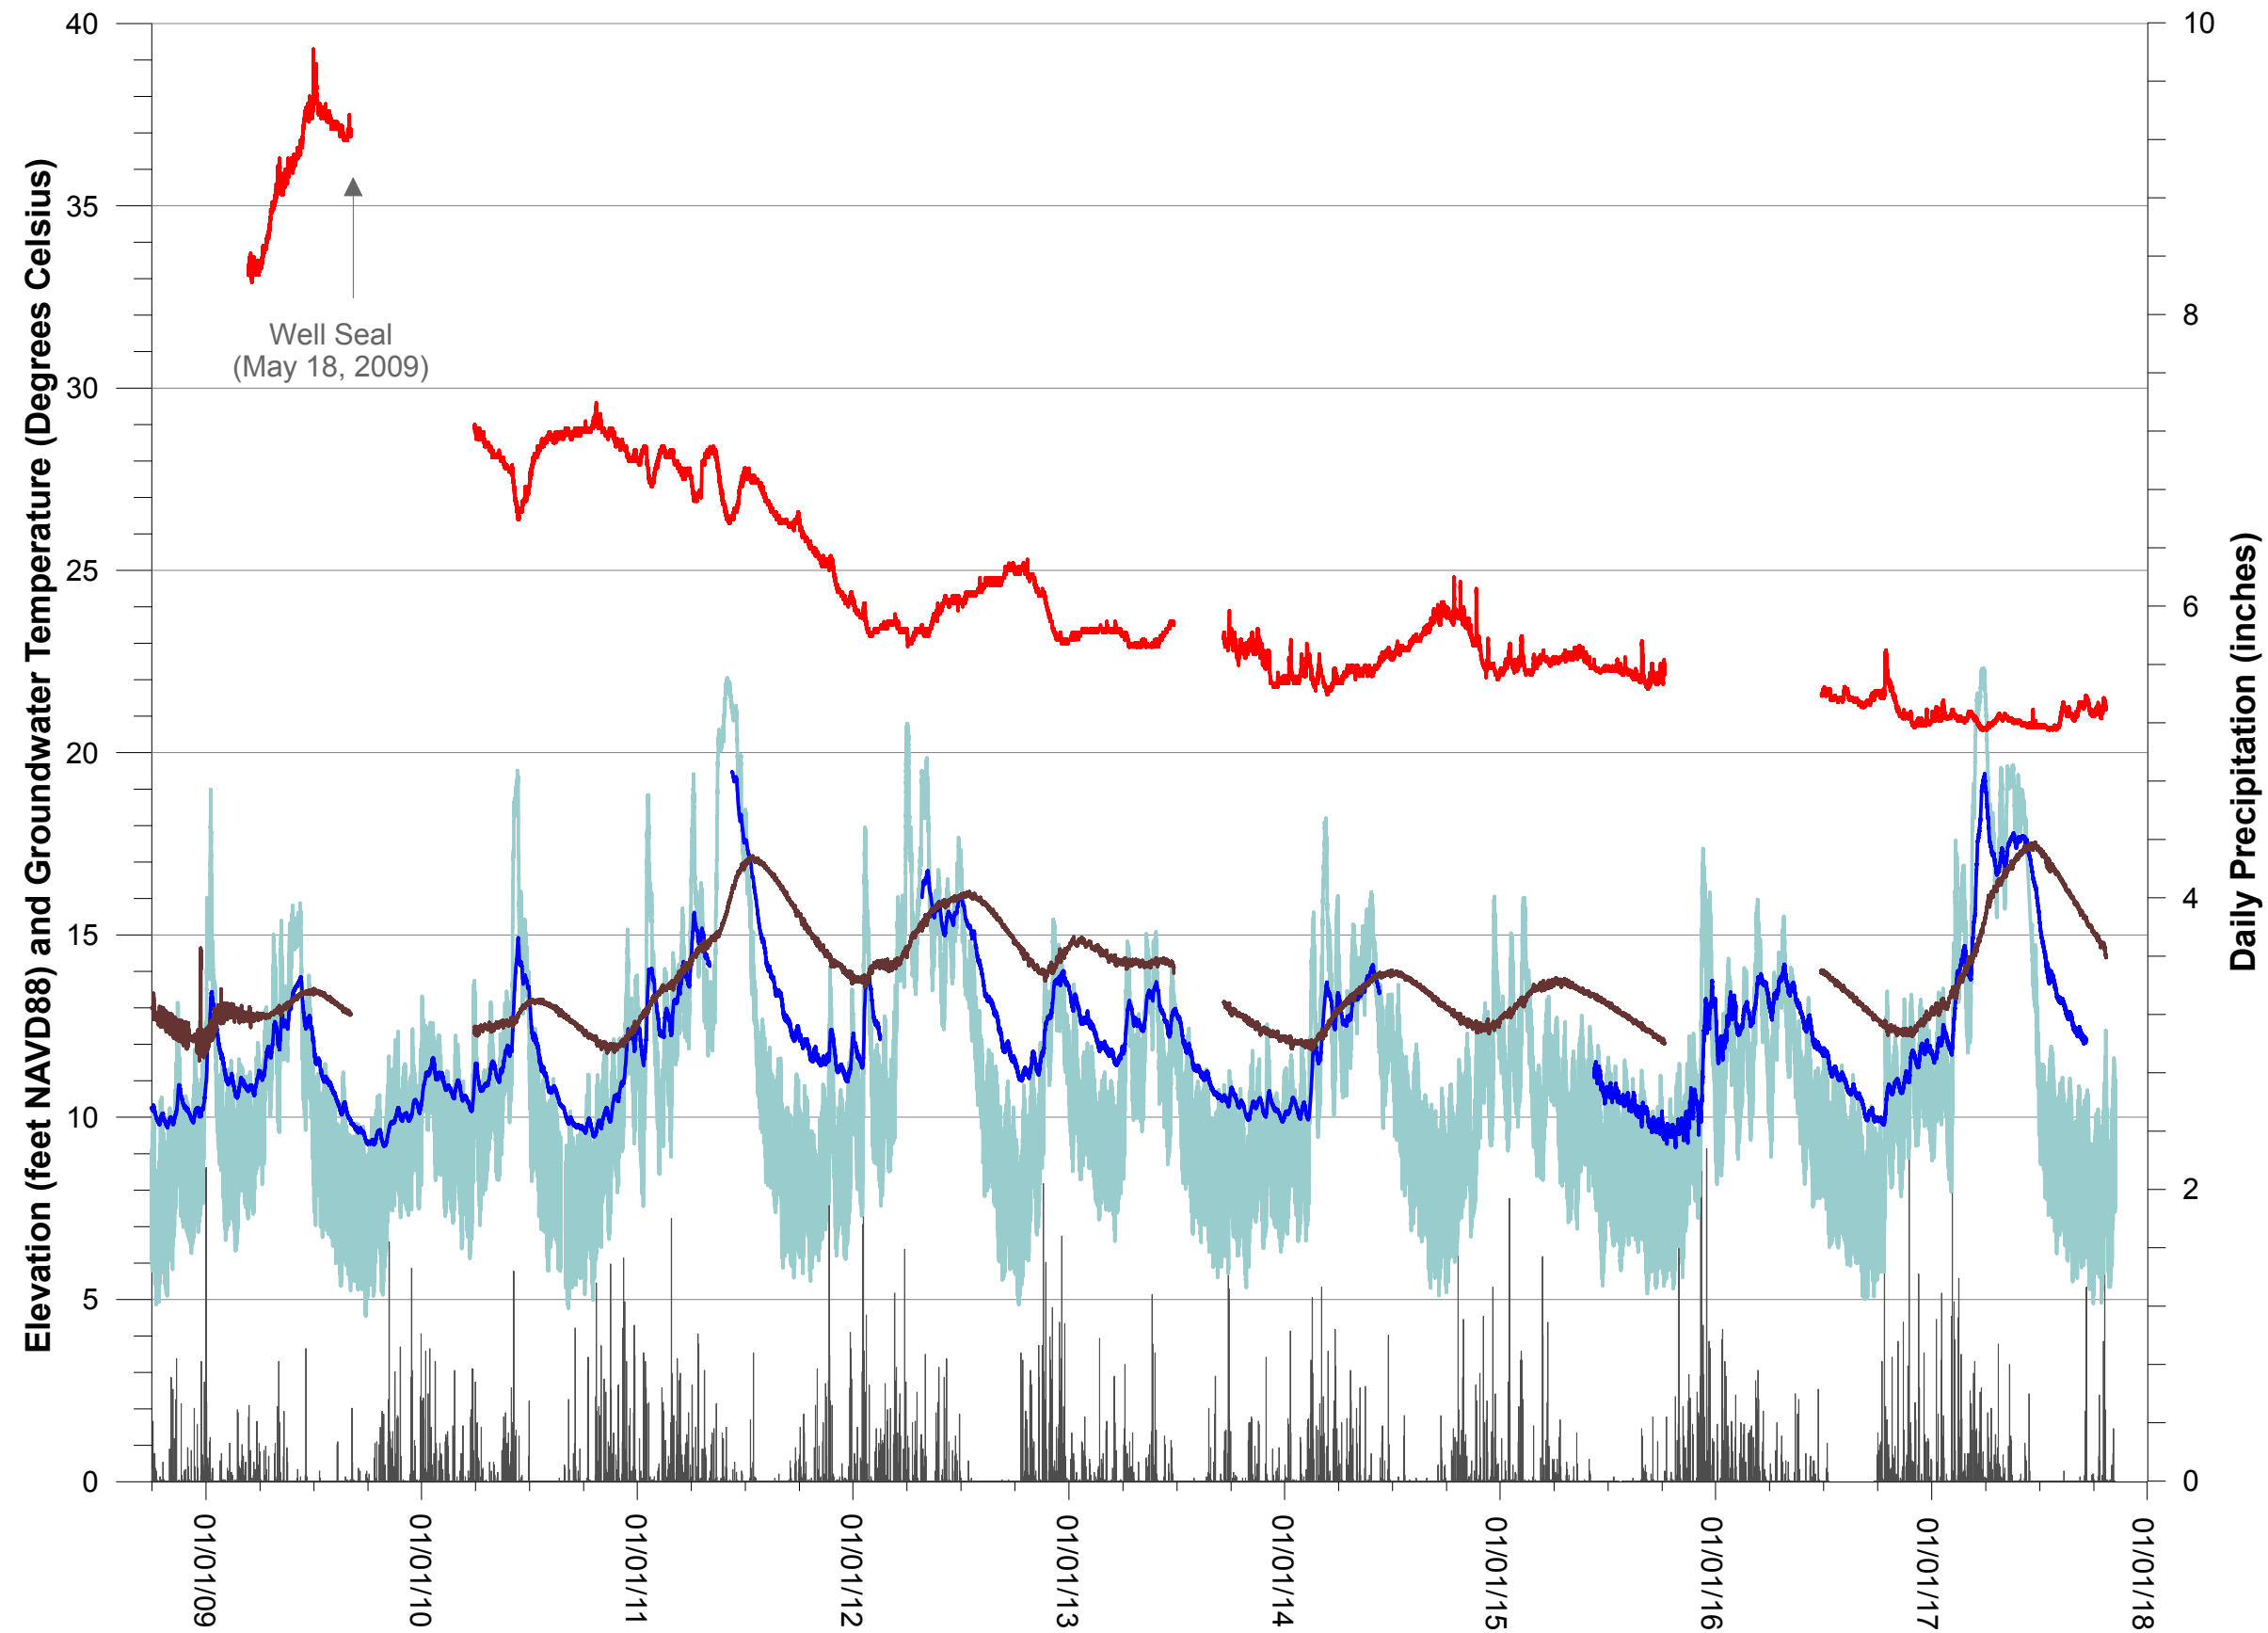
**Figure 4-6:
2008 to 2017 Groundwater Temperature
in Montoring Well EW-1s and
Groundwater Elevations
Monitoring Wells MW-36s and EW-1s
McCormick and Baxter Superfund Site
Portland, OR**

Based on elevated groundwater temperatures in well EW-1s (40 °C) and the large amount of buried woody debris in the area, it was suspected that aerobic degradation of woody debris was occurring and causing the ground surface subsidence. Decreasing groundwater levels within the barrier wall also may have contributed by opening a larger unsaturated zone that allows compaction. In 2009, the shallow well EW-1s was sealed to reduce the amount of oxygen reaching the unsaturated zone. After the well was sealed, subsidence slowed with no additional subsidence being observed over the past 5 years. The groundwater temperature dropped to approximately 21-23°C and has remained stable for the past 5 years. This temperature is still higher than groundwater from surrounding wells (approximately 13°C) indicating that some heat is still being produced in the subsurface near well EW-1s; this may be caused by anaerobic degradation, which generates less heat than aerobic degradation.

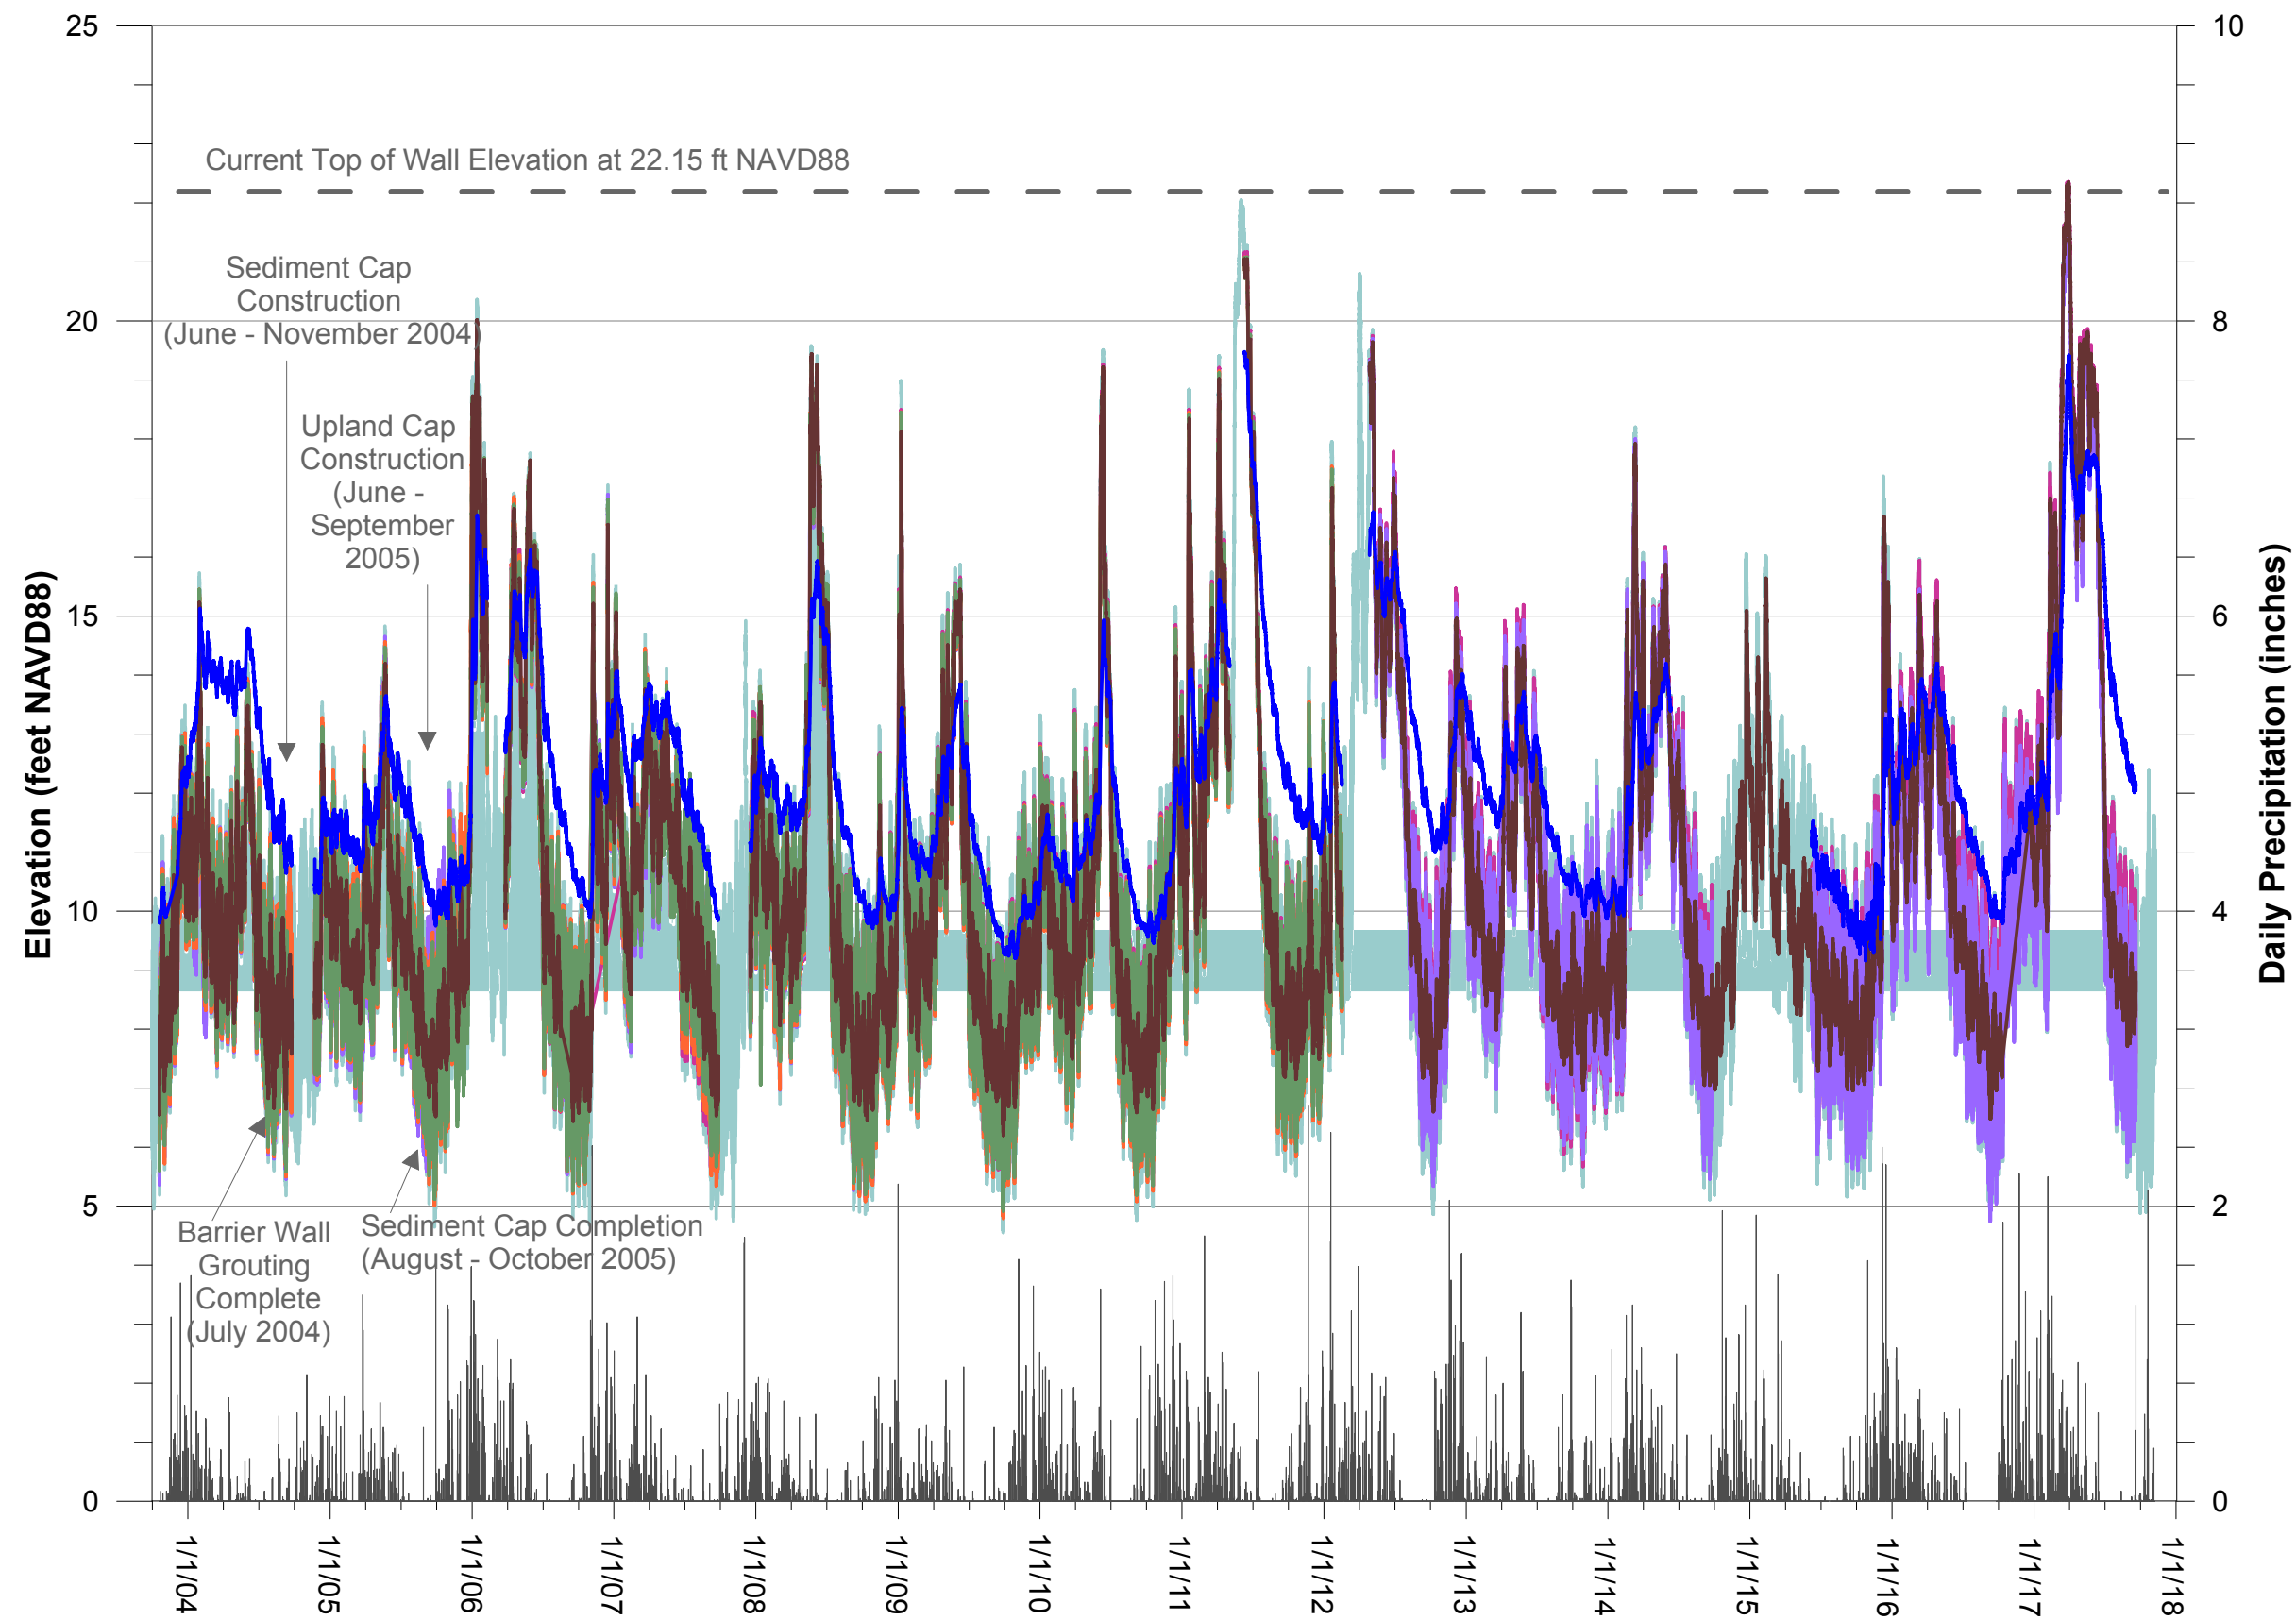
Figure 4-8:
Post-Barrier Wall Groundwater Elevations
in Monitoring Wells MW-36 and MW-37

Vertical gradients inside and outside the barrier wall along the Willamette River were observed in monitoring well clusters MW-36/MW-37 and MW-44/MW-45. The hydrographs for these wells (Figures 4-8 through 4-11) indicate that the deep groundwater zone is in direct hydraulic connection with the river. The deep zone both inside and outside of the barrier wall closely mimics the river stage, both in elevation and timing, with small vertical gradient changes that occur in response to the daily tidal changes and seasonal river stage trends. The exterior shallow wells, also in hydraulic connection with the river, show about a quarter cycle delay from river fluctuations and have dampened amplitude in comparison with the deeper wells.

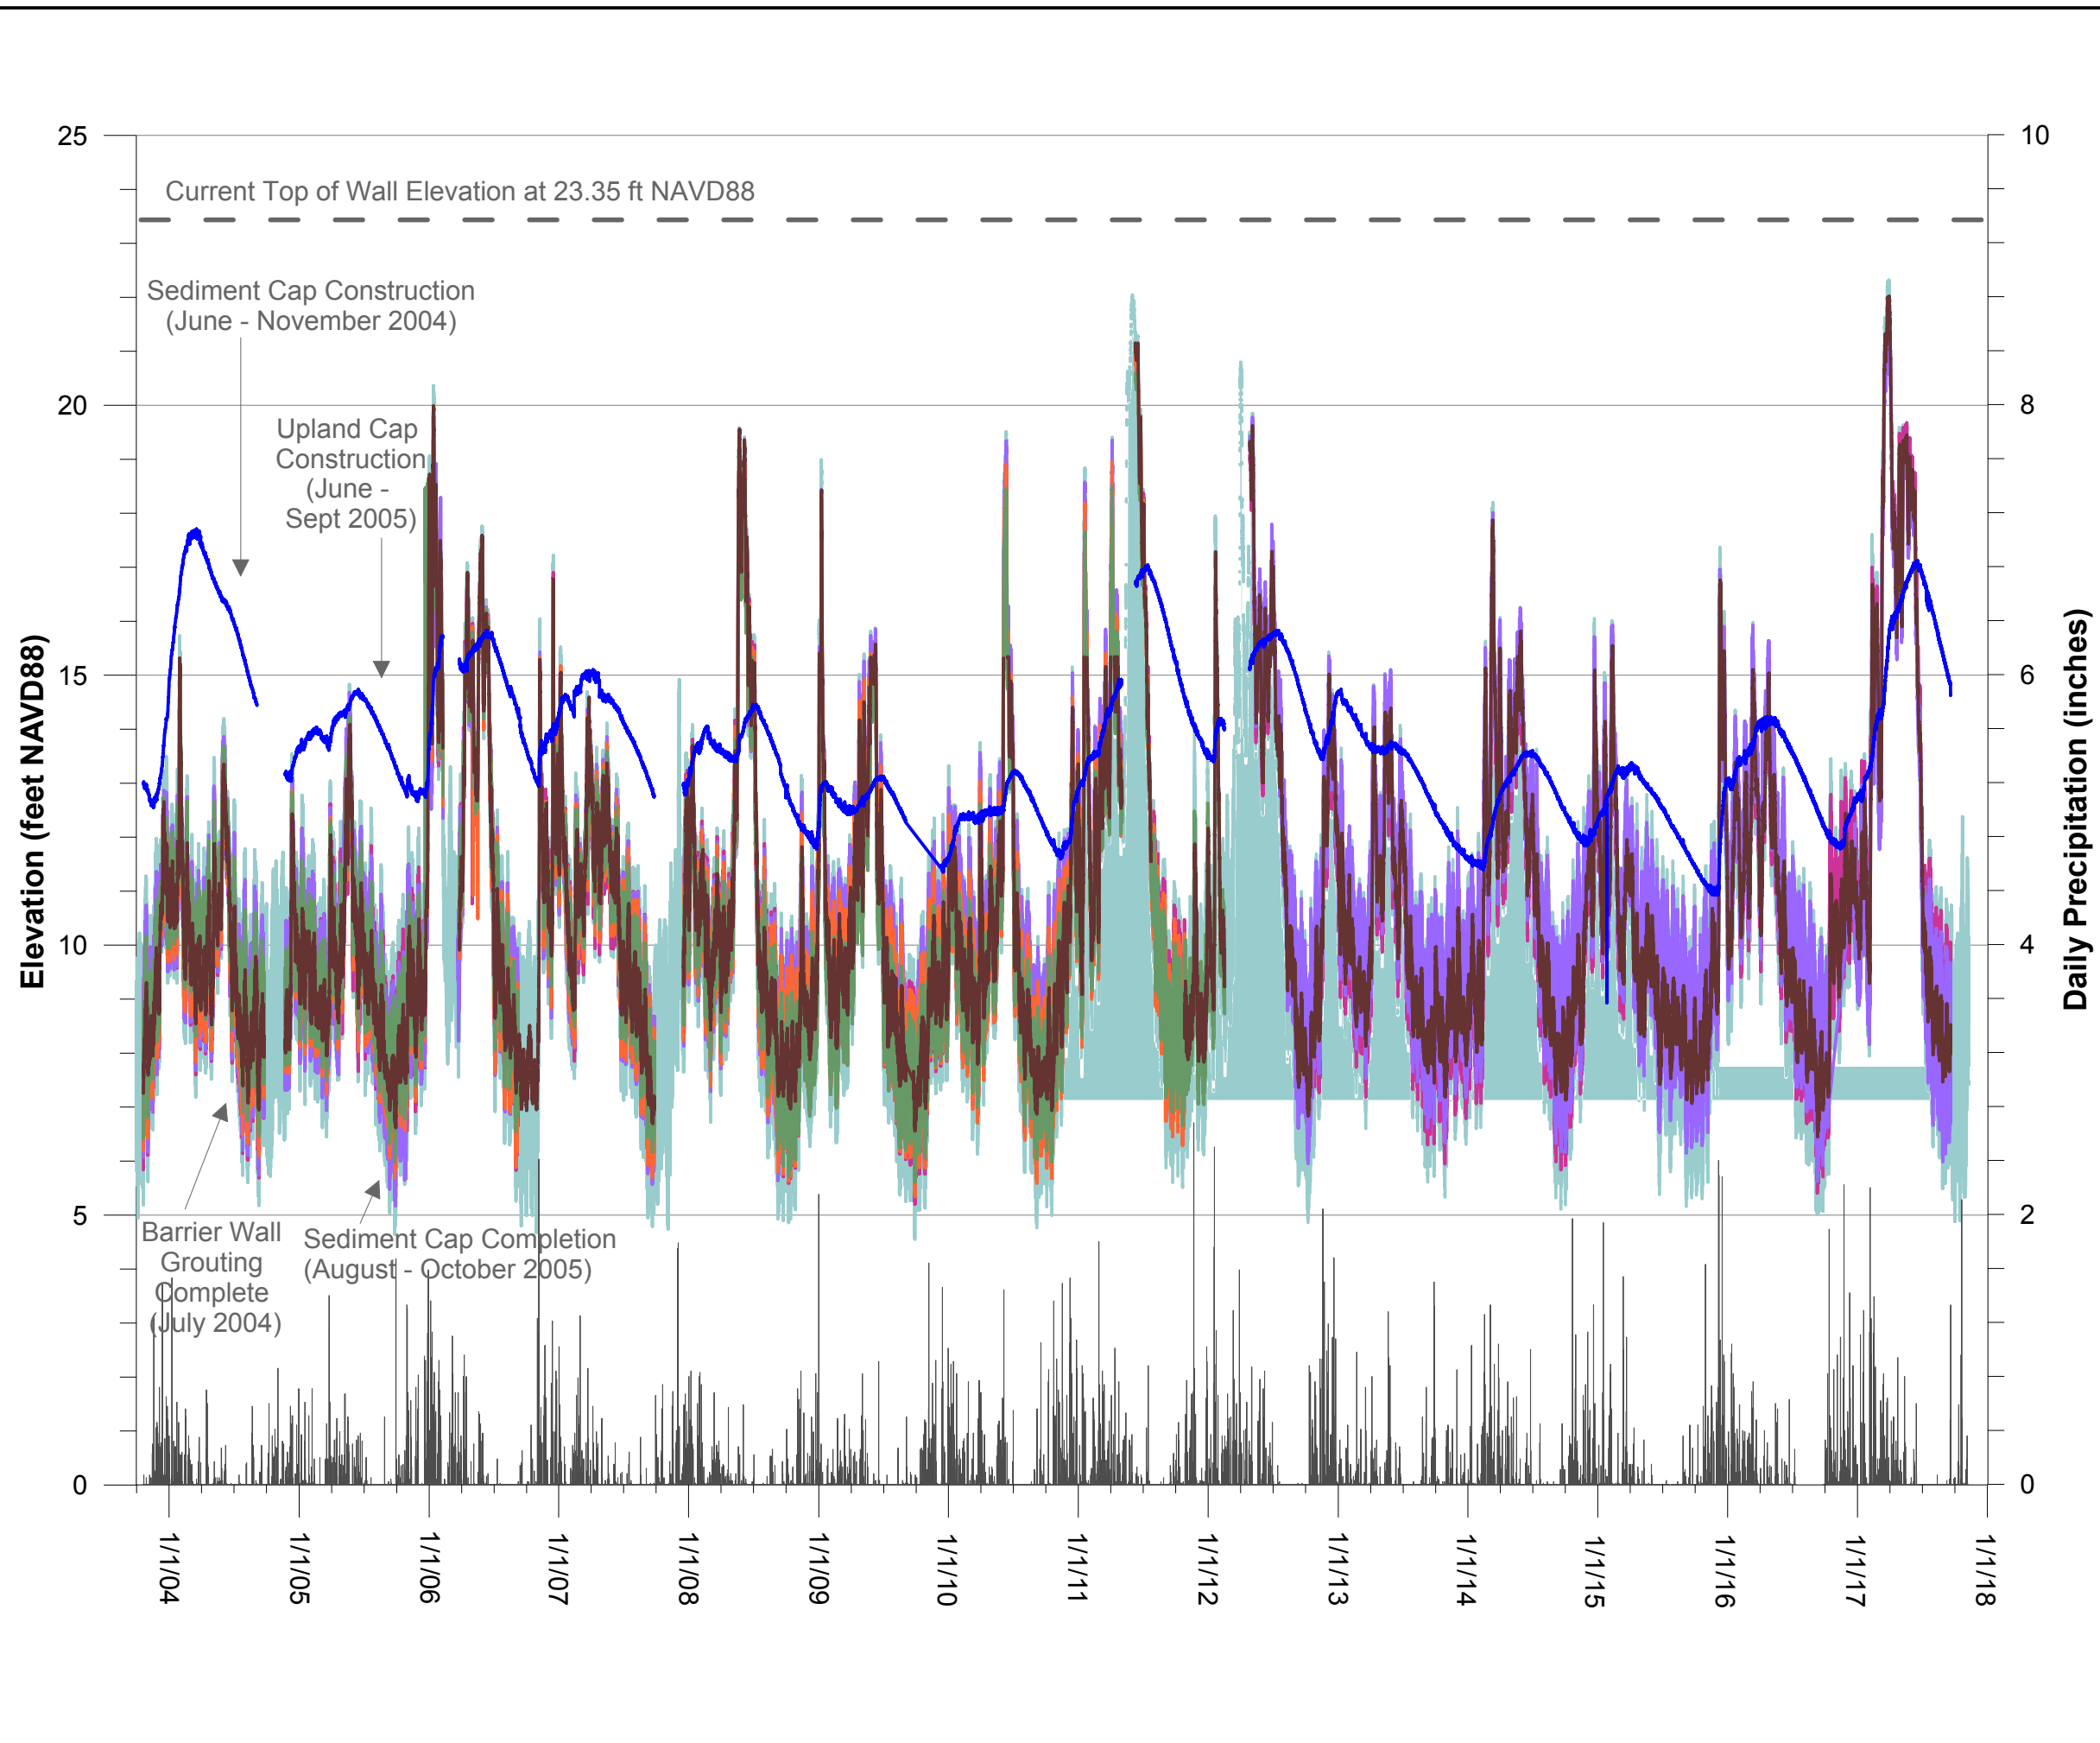
Figure 4-10:
Post-Barrier Wall Groundwater Elevations
in Monitoring Wells MW-44 and MW-45

The muted or nonexistent response of interior shallow wells compared with the deep zone wells suggests a clear hydraulic disconnect between the shallow aquifer within the barrier wall and the deeper water-bearing zones. The location where the response is greatest, but still significantly muted, is in well MW-36s (Figures 4-6 through 4-9), where a hydraulic connection exists at the base of the barrier wall. While a muted response of well MW-36s to changes in daily river stage elevation is still observed, water levels in the shallow interior wells MW-44s and EW-1s are virtually nonresponsive to the daily changes in the Willamette River stage (Figures 4-10 and 4-11 for MW-44s, and Figures 4-6 and 4-7 for EW-1s). This reflects the presence of a confining silt layer between the shallow and intermediate zones near wells MW-44 and EW-1s.

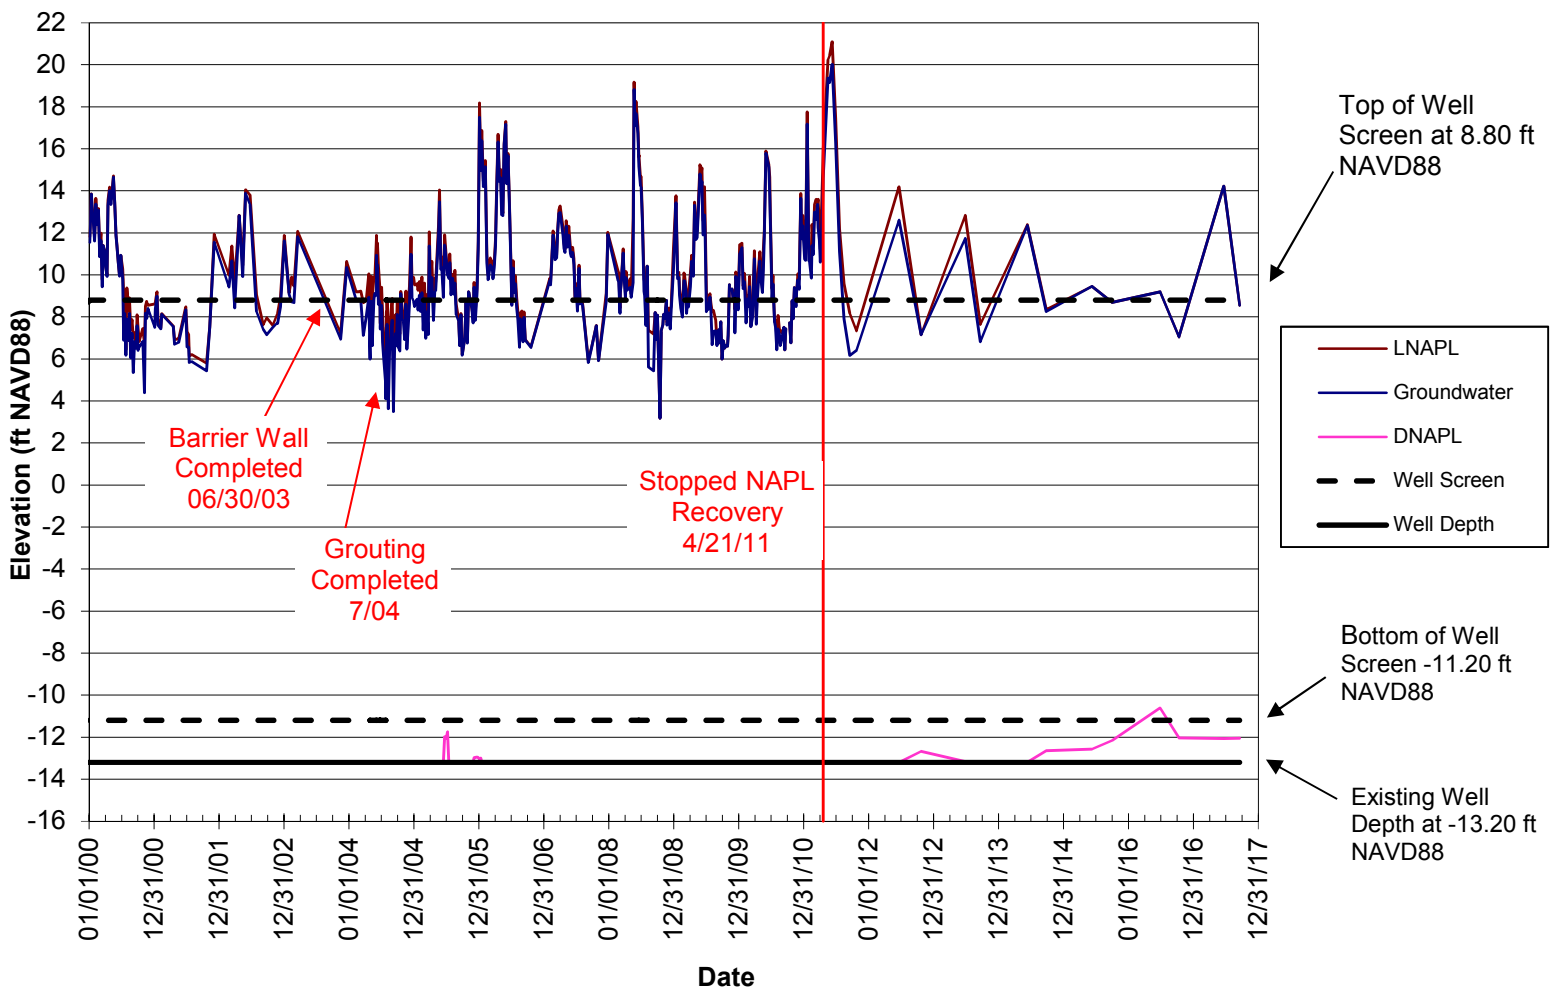
Figure
4-14

The only area where NAPL is observed routinely outside of the barrier wall is next to the northwest corner of the enclosure (Figure 1-3) that corresponds to the FWDA (Figure 1-5). In 2017, measurable quantities of DNAPL were observed in four wells (EW-10s, MW-20i, MW-Ds, and MW-Gs) in this area. As shown on Figures 4-14 through 4-17, the DNAPL thicknesses measured in these wells in 2017 are generally stable since NAPL recovery was discontinued in April 2011. This is consistent with historical

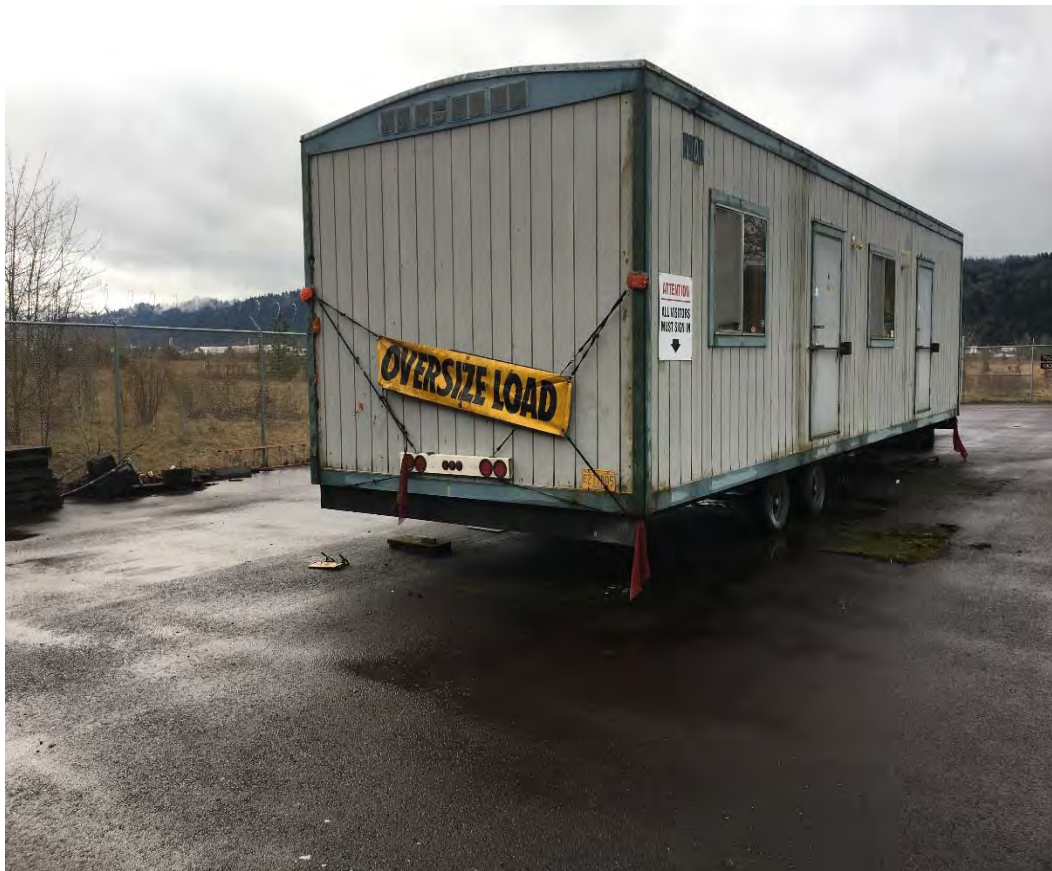
Photograph 2 – Trailer removal in February 2017.

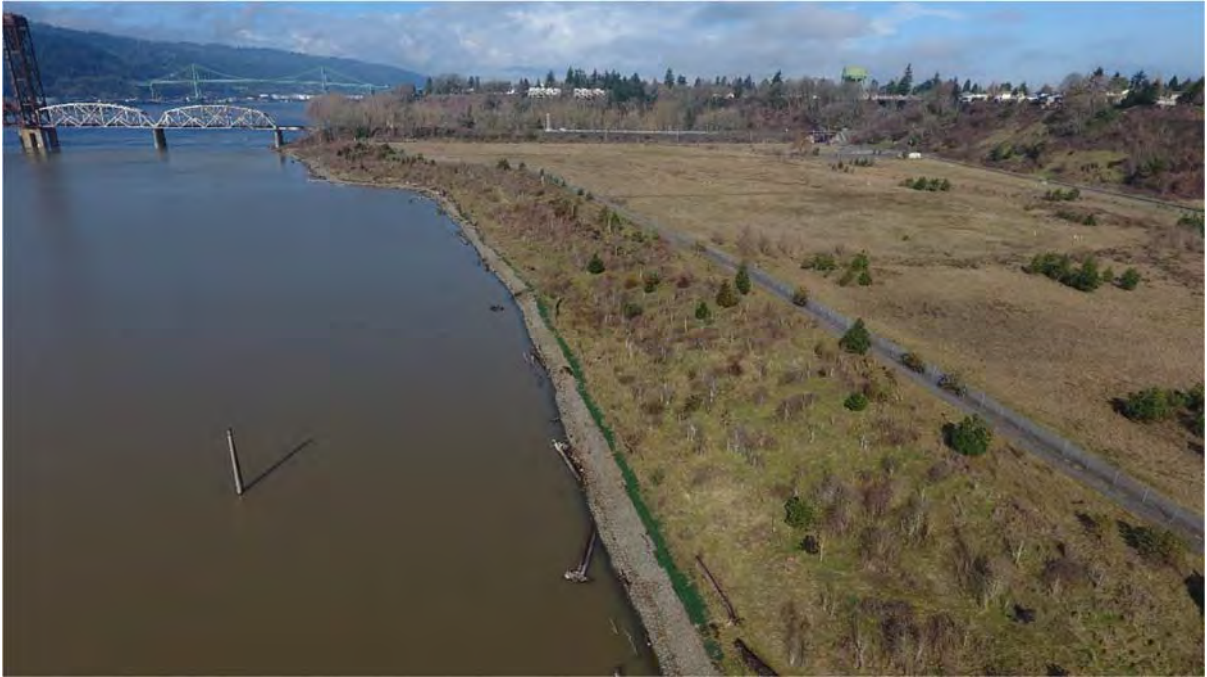
Photograph 5 – Looking north at riparian area on February 23, 2017.

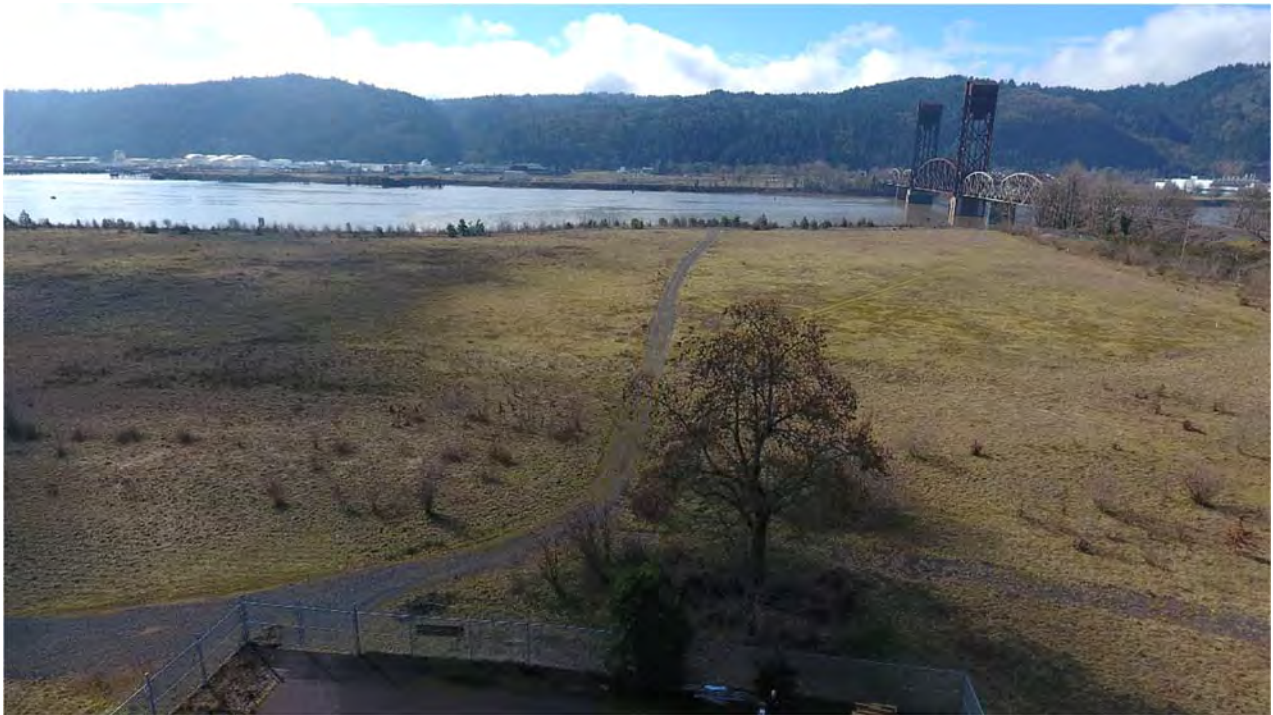
Photograph 6 – Looking east at north section of upland soil.

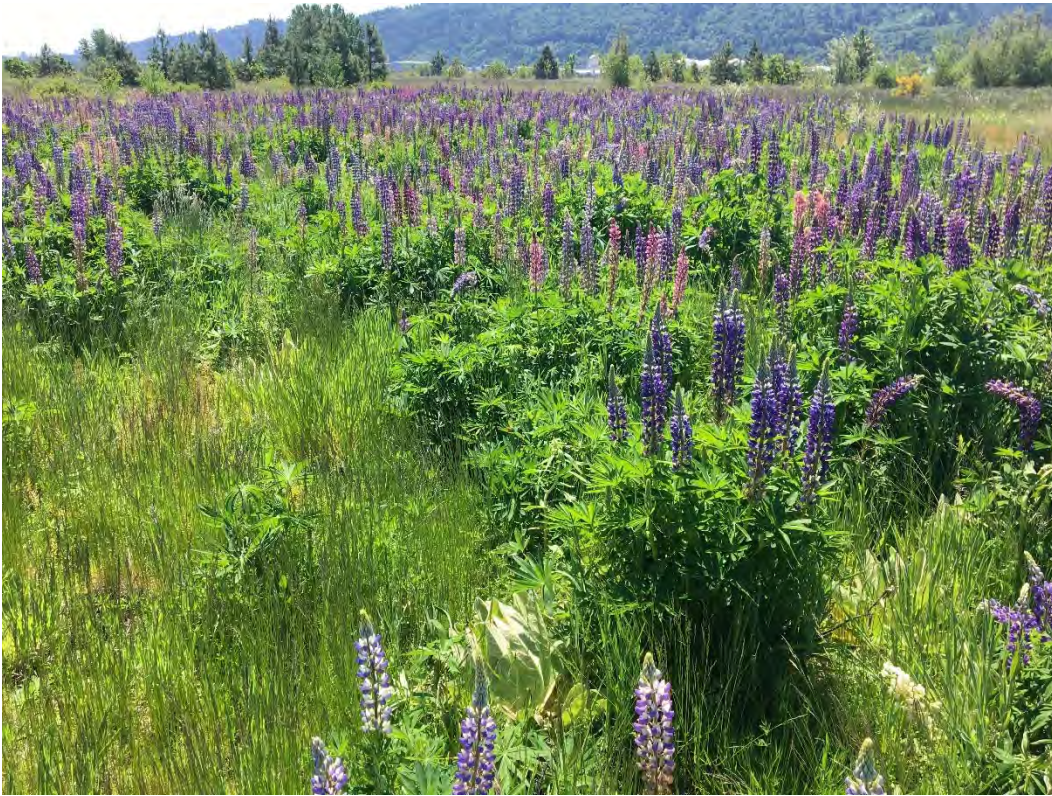
Photograph 7 – Looking southeast at lupine on central portion of upland soil cap in May 2017.

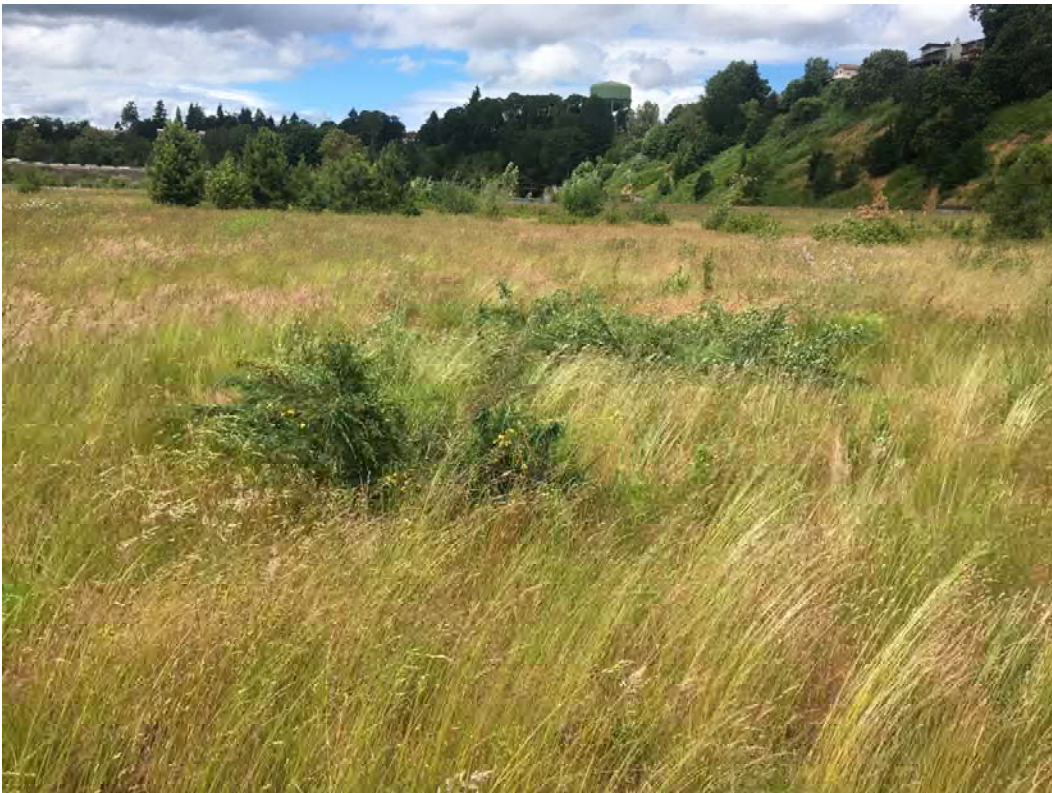
Photograph 8 – Scotch Broom removal on upland soil cap following spring weed control activities.

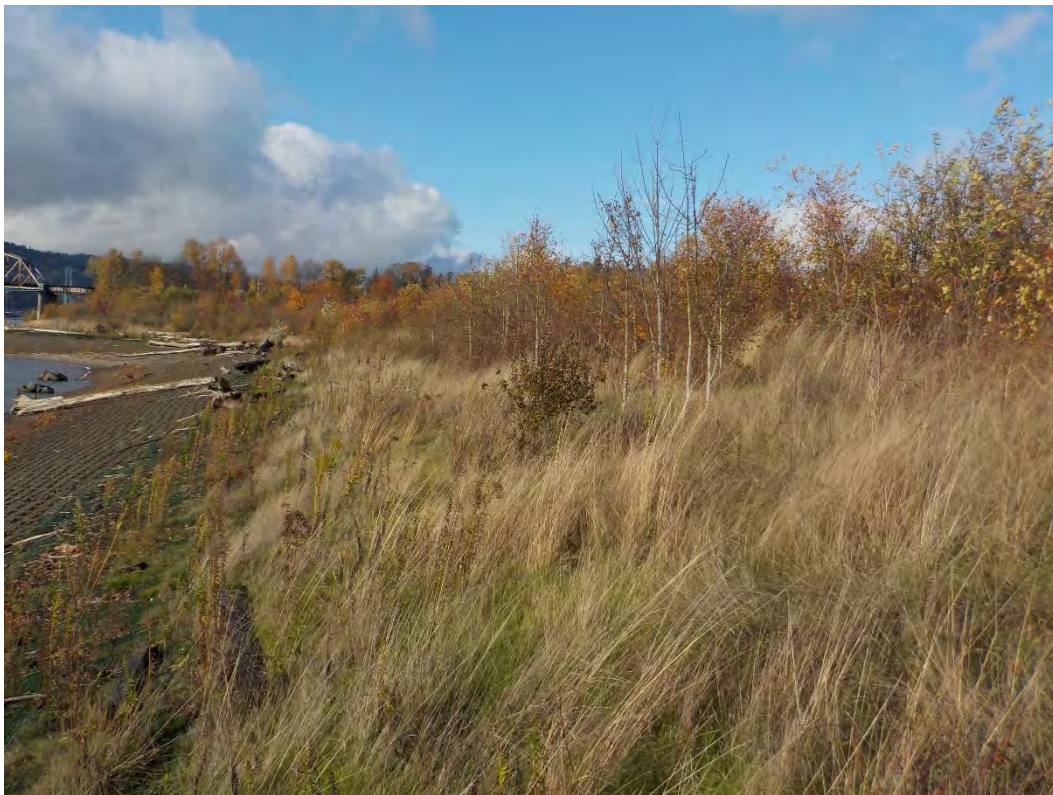
Photograph 10 – Looking south at the riparian area observed during the fall vegetation inspection.

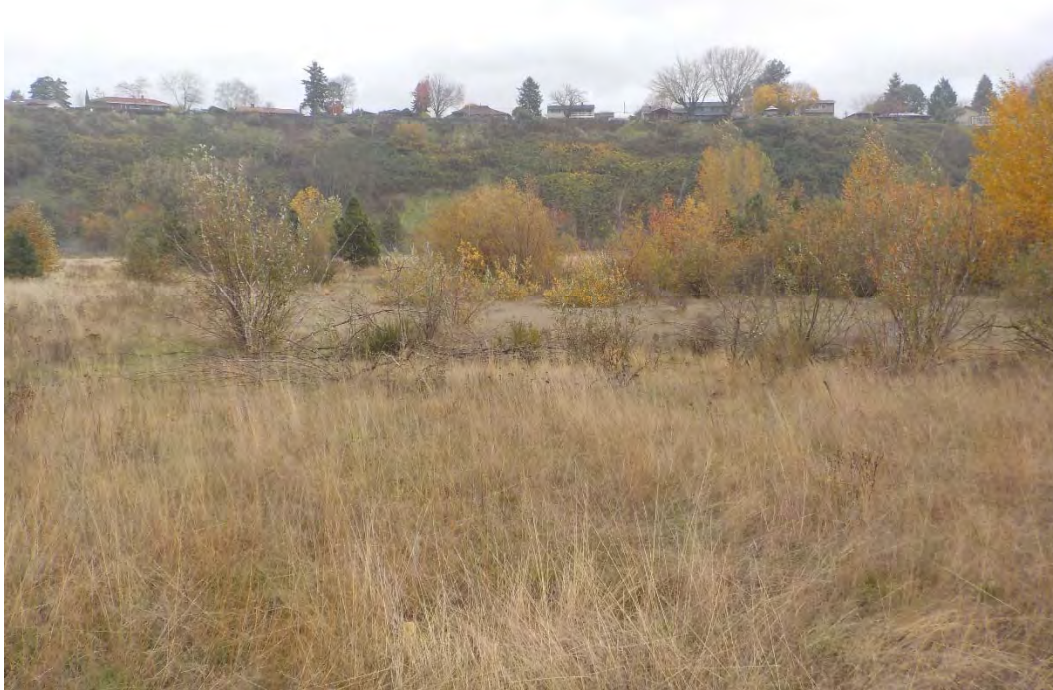
Photograph 12 – Detention pond in October 2017.

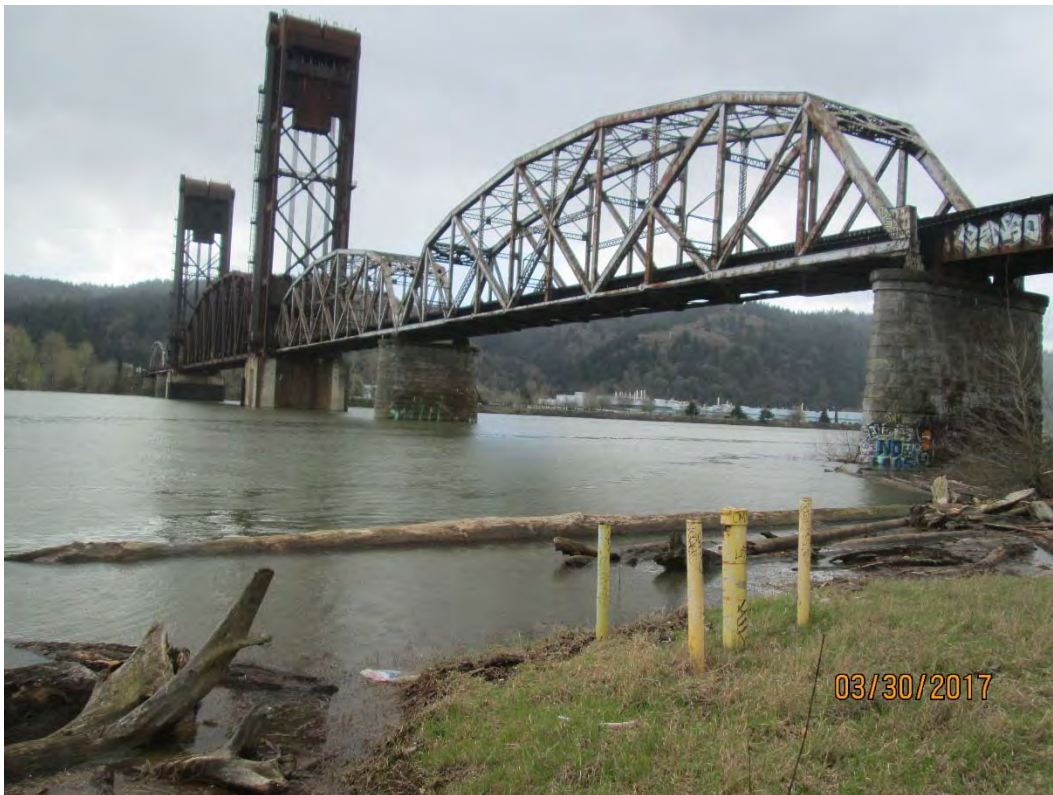
Photograph 14 – Highest river level of 2017 observed at the south end of the riparian area on March 30, 2017.

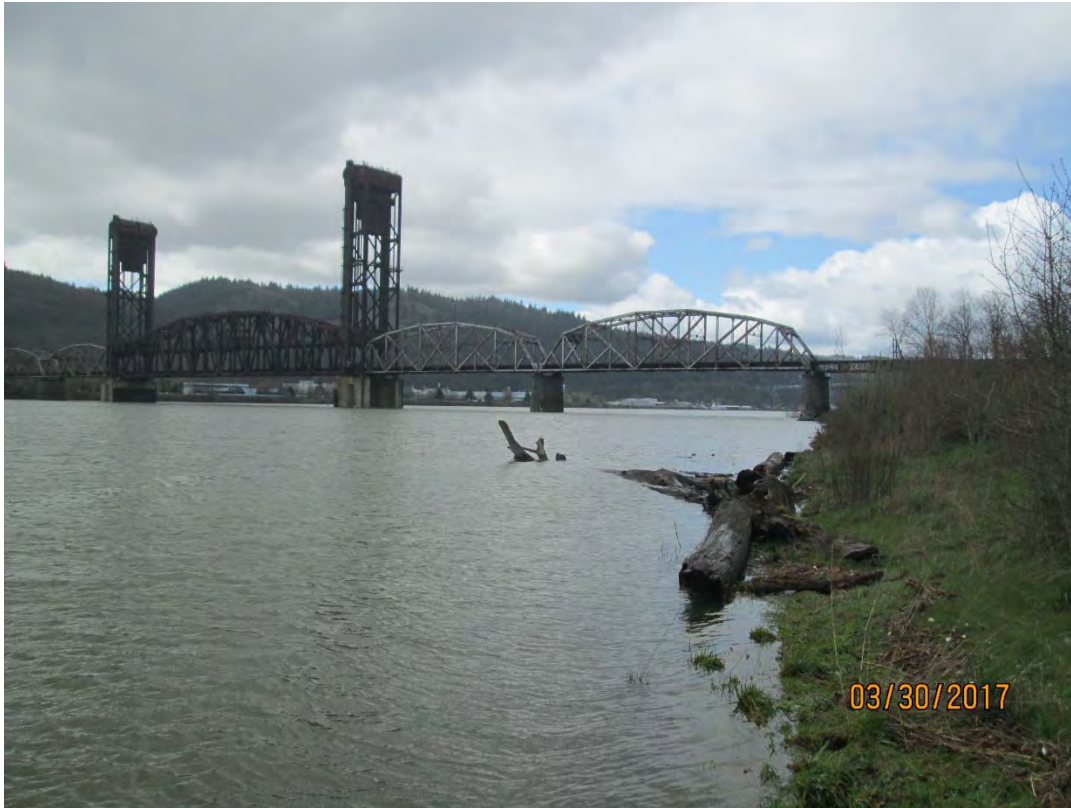
Photograph 15 – Highest river level of 2017 observed at the south end of the riparian area.

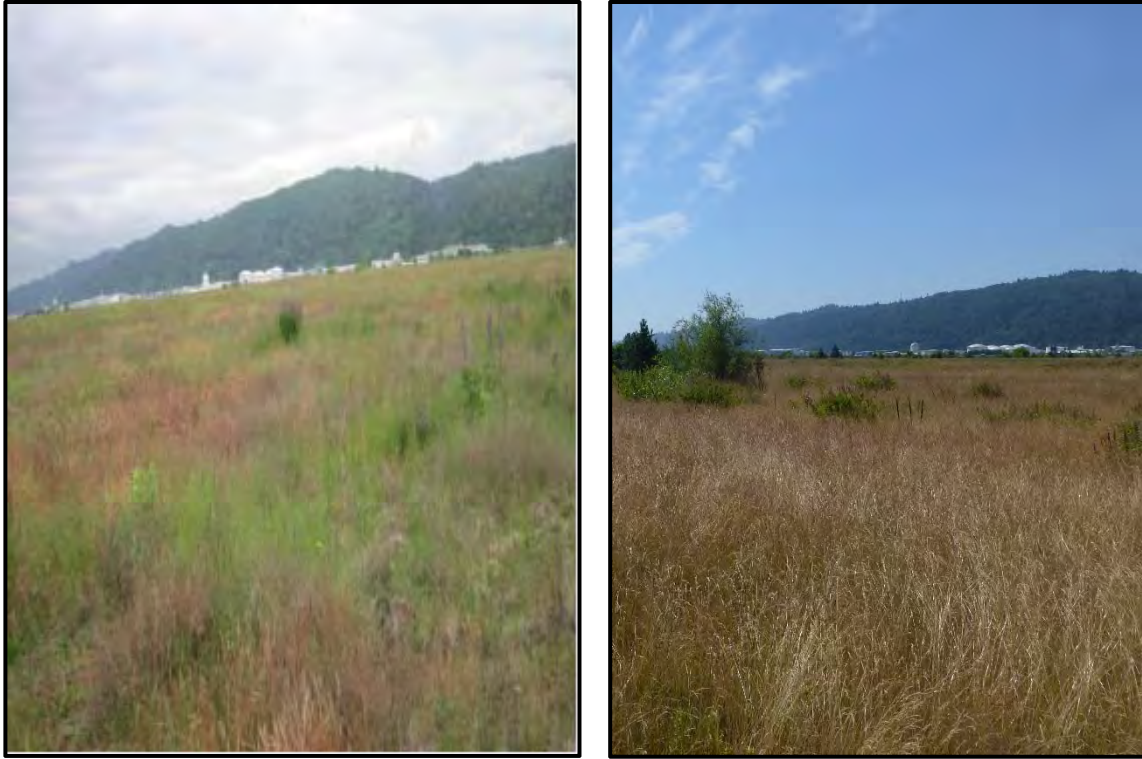
Photograph 1 – Earthen cap and drainage swale in the foreground with the impermeable cap in the background. Taken looking south from Photograph Station 1 comparing baseline and current conditions. (Left - June 2011; Right - June 2017)
